Health & safety practices in Russia: tips from professionals

Learning from the incidents: case study

Conveyor Accident

Lessons Learnt

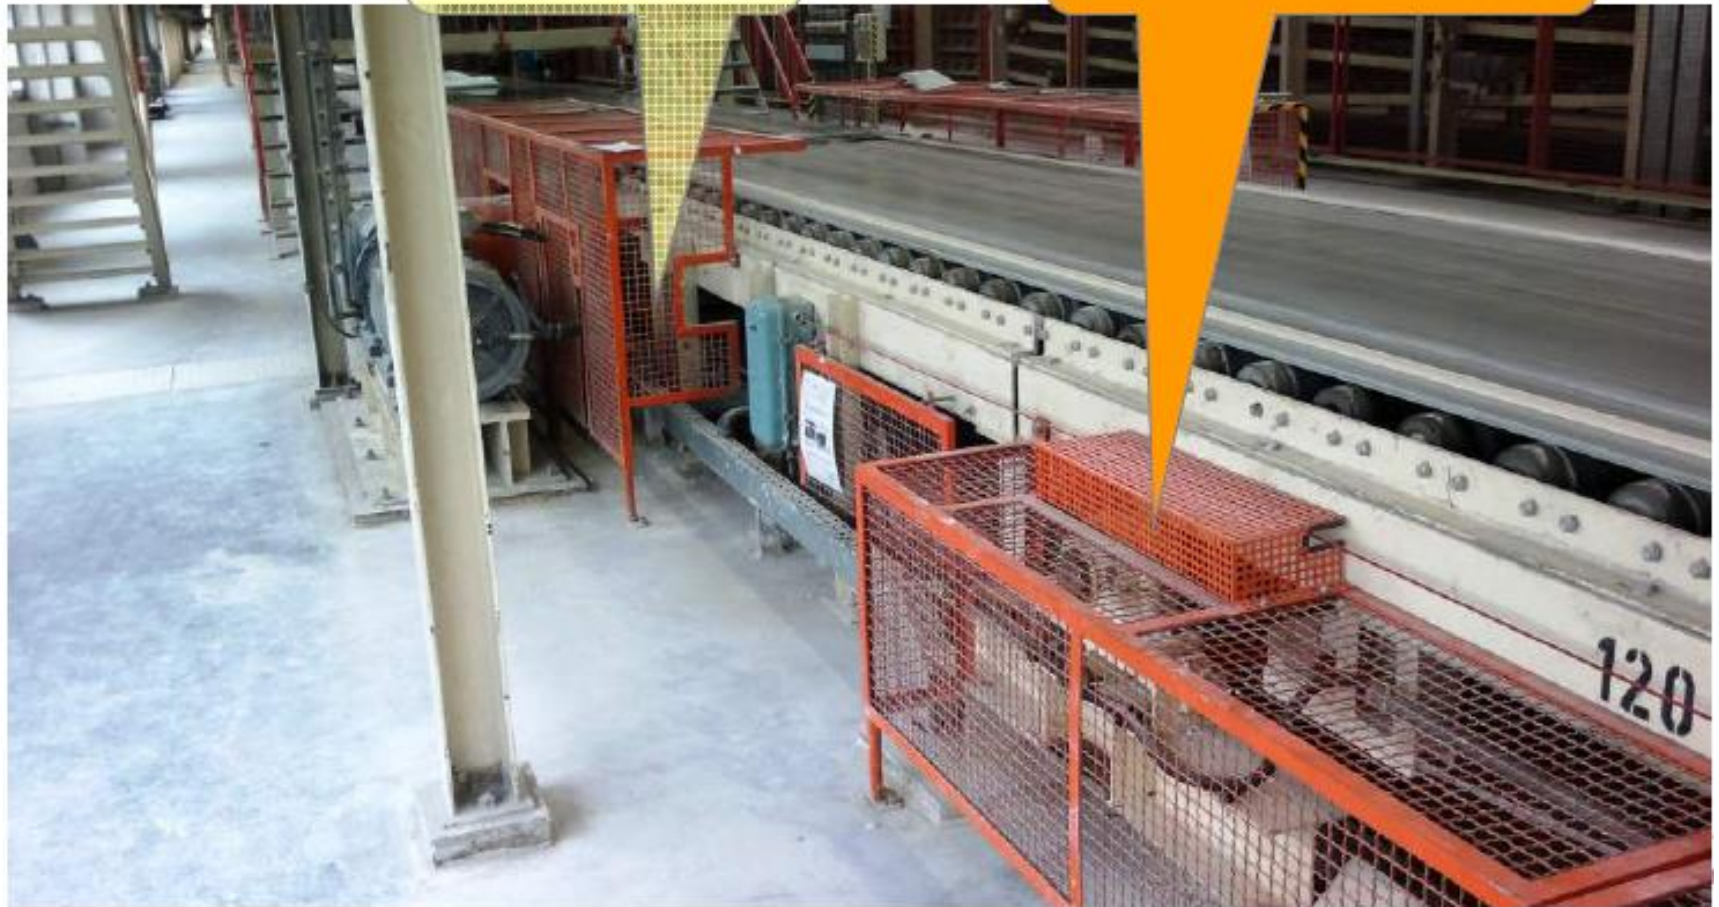
Reconstruction of the accident

Tracking sensor
setting belt 1 channel
side

Place of accident,
return drum of tensioning section
setting belt 1 channel side

Normal production was running when an operator near the mixing area heard somebody screaming at the end of forming belt 1. An operator immediately went to the end of belt 1 and saw the injured person with the right arm squeezed between the tensioning drum and the forming belt. First aid measures were taken and ambulance was called. Production was stopped until initial investigation.

- ▶ Production was restarted after the tracking problems without two fences at the tracking sensor remounted, operators were instructed by shift-leader to start the cleaning only after the machine stop for week-end (1:45 h later)
- ▶ The fence at the return drum of the tensioning system, where the accident happened, was not dismantled to reset the tracking sensor. It is unclear whether the fence was dismantled during production stop to clean or whether the injured person dismantled the fence during running machine. It is not possible to imagine how the accident should have happened with the fence on
- ▶ Inspection with the intention to clean with a scraper was performed at **the operating setting belt drum** without the fence mounted (see above, there is no evidence or witness to confirm that the fence was mounted)
- ▶ **Existing procedures and rules were broken with conscience!**

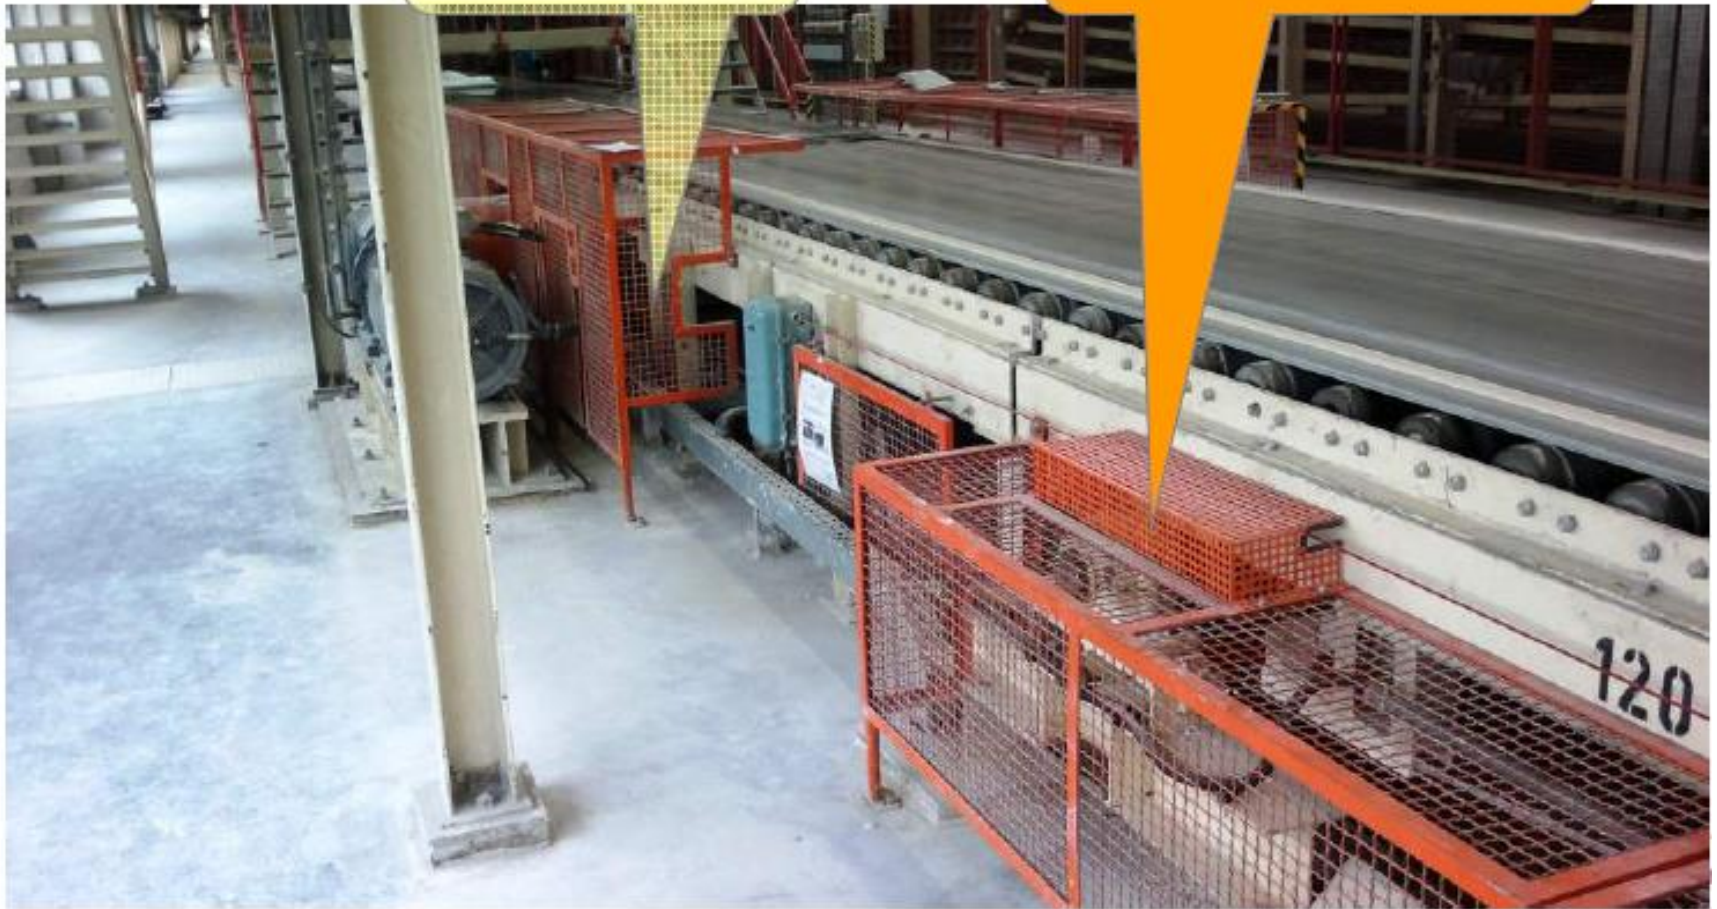
Reconstruction of the accident

Tracking sensor
setting belt 1 channel
side

Place of accident,
return drum of tensioning section
setting belt 1 channel side
